# Amalfi in Lancashire

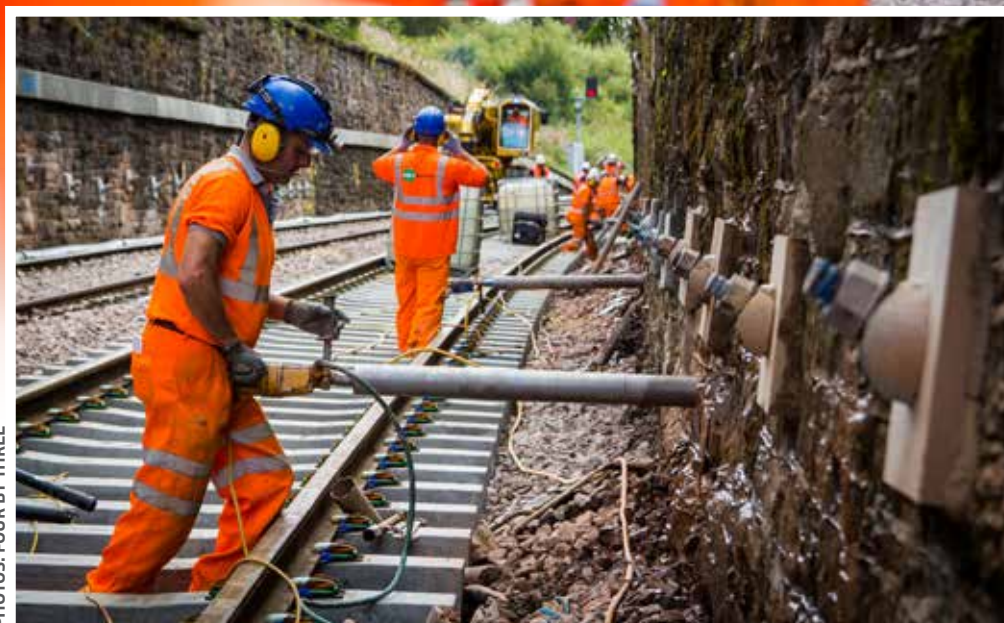
**(Above) Weep holes are inserted below the retaining walls' ground anchors.**

**(Top) Dropping the tracks by 500mm through the tunnel has created space for overhead line equipment.**

Just 113 metres long, Chorley Tunnel features vertical masonry sidewalls with a segmental arch in sharply dressed stone. Below, built on a 200mm sandstone slab, is a brick invert – 550–600mm deep, measured vertically. Whilst ballasted track could have been engineered for electrification purposes, achieving W12 loading gauge through the tunnel necessitated a track slab solution to limit intrusion on the invert, although notches still had to be cut into it to create the space needed. Ground investigations had helped to build an initial profile of the invert – as best as you can using trial pits – but only after it was exposed and surveyed during the blockade could the depth of the notches be confirmed: mostly around 300mm, with 400mm as a worst case.

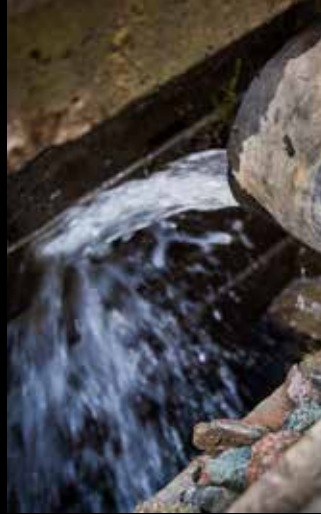
**The extent of the track lower can be gauged by floor level in the refuge.**

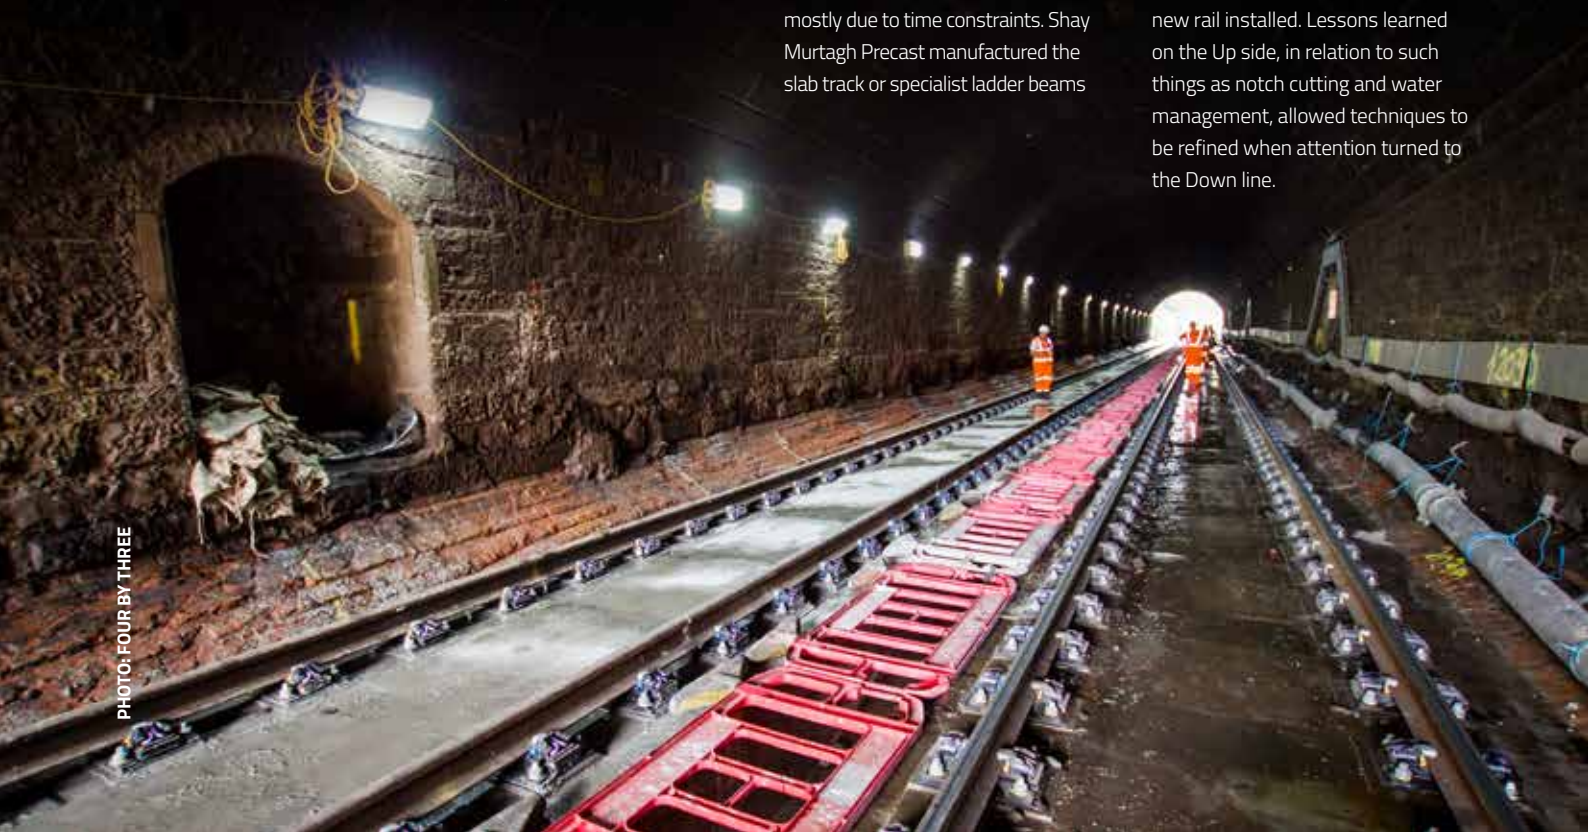
An installation methodology was developed to keep the length of open notch as short as possible at any one time. Starting with the Up line, work progressed cyclically – cut the notch, position the ladder beams, grout up – generally in 15-metre bays; this was reduced to 5 metres in critical areas where a deeper notch was required, thus ensuring any stresses were temporarily transferred into the adjoining brickwork. Thereafter the Vipas were fitted – their holding-down sockets having been precast into the ladder units – and new rail installed. Lessons learned on the Up side, in relation to such things as notch cutting and water management, allowed techniques to be refined when attention turned to the Down line.

Stobart Rail, the p-way sub-contractor, and Murphy proposed a precast concrete ladder system for the track slab rather than an in-situ pour, mostly due to time constraints. Shay Murtagh Precast manufactured the slab track or specialist ladder beams

each 4.525m long 2.257m wide, 34 no. upline and 34 no. downline with an overall length of 307.7m. Pandrol Vipa baseplates were specified to provide the high degree of fixity needed for clearances of at least 50mm and a minimum-width six-foot.
